WASCANA CENTRE LANDSCAPE ASSESSMENT

FINAL REPORT

Submitted to
Wascana Centre Authority

By
Crosby Hanna & Associates

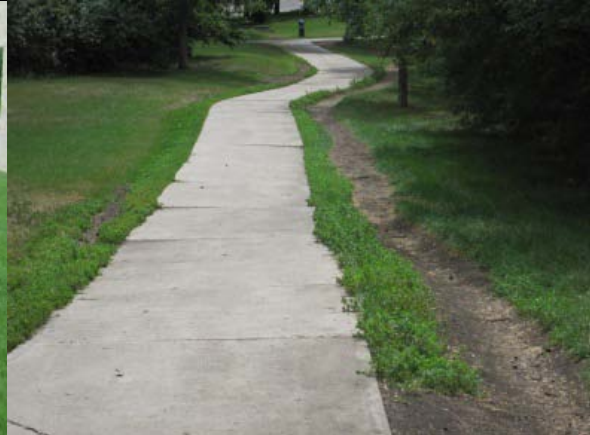
Problem: Pedestrian and vehicle wear beside narrow pathways.

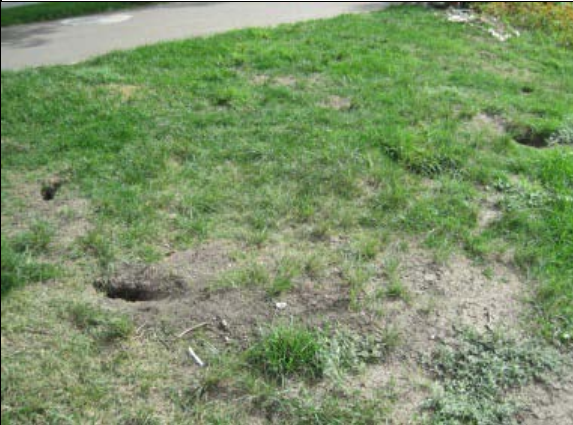
Problem: Ground squirrel holes.

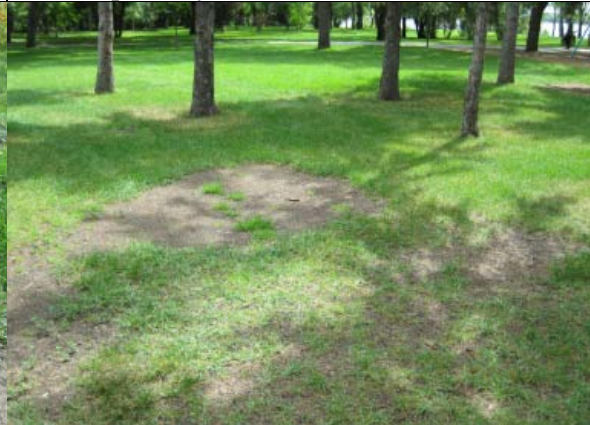
Problem: Patchy grass underneath trees.

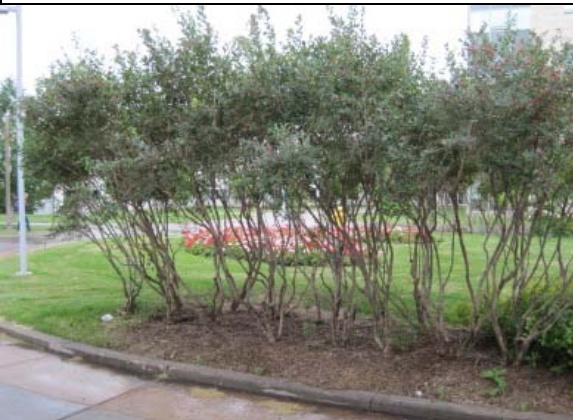
Problem: Long and leggy Honeysuckle with no growth at base.

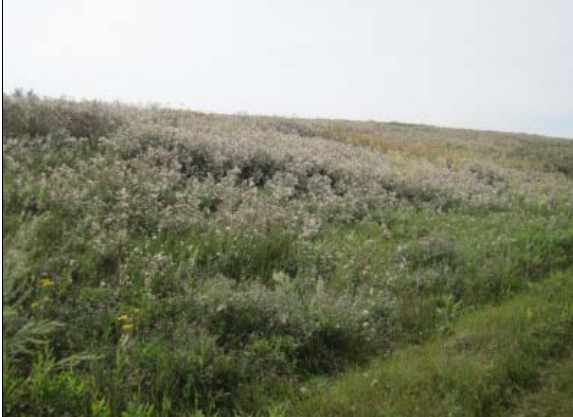
Problem: Infestations of Canada thistle.

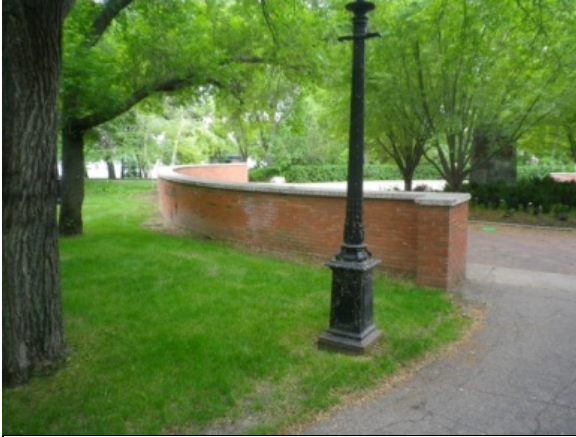
Photo 3: North-west Wall Leaning Outwards

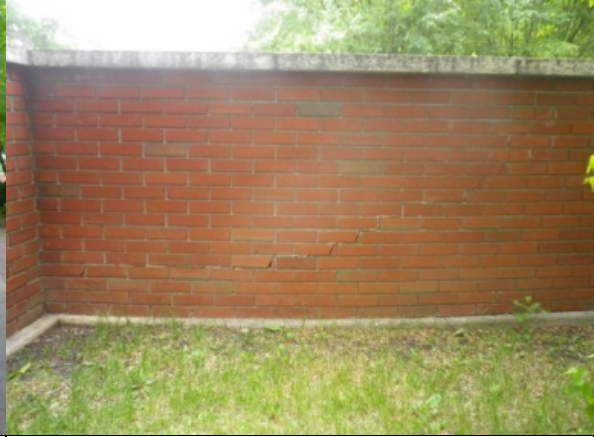
Photo 4: Cracks in North-east Wall

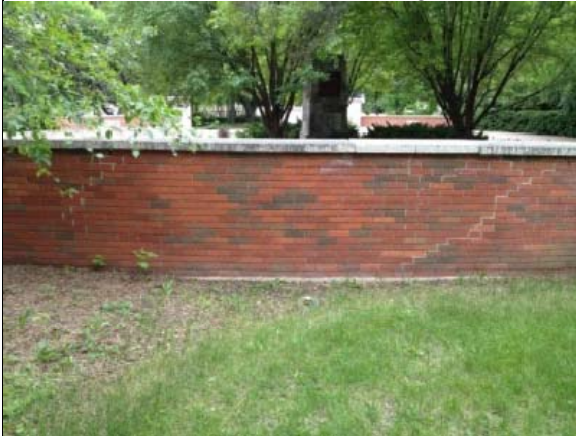
Photo 5: Cracks in North-east Wall

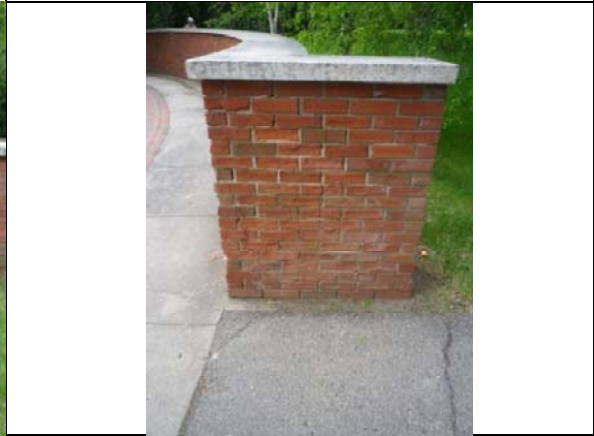
Photo 6: Deterioration of Brick on North-east Wall

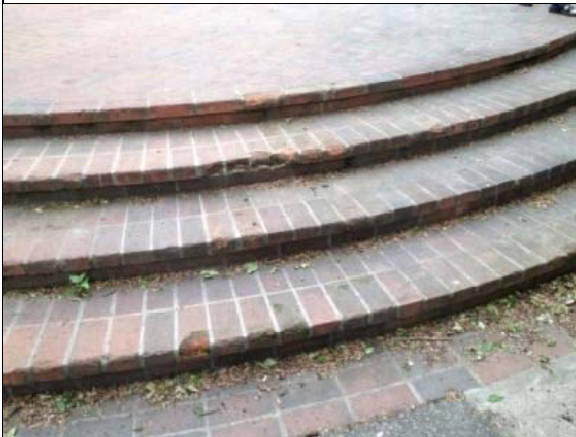
Photo 7: Deteriorated Stairs

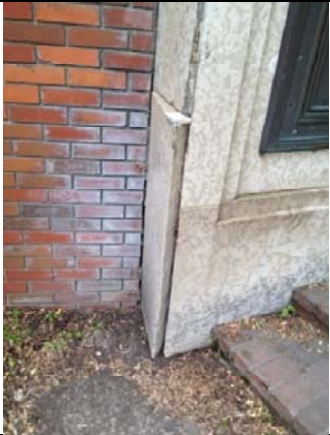
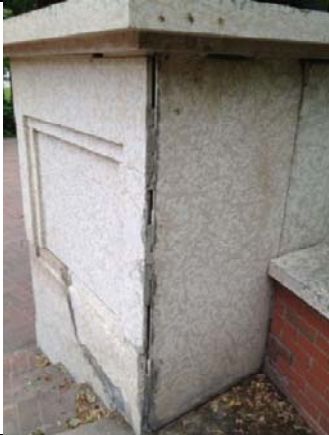
<p>Photo 9: Offset Stone on West Monument</p>	<p>Photo 10: Cracked Stone and Mortar Deterioration in West Monument</p>

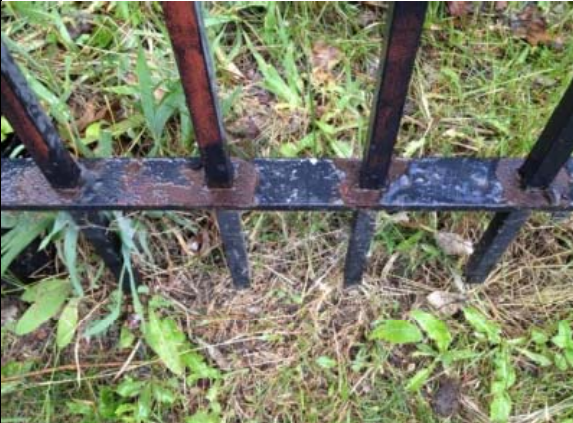
Photo 5: Peeling Paint and Corrosion on Fence

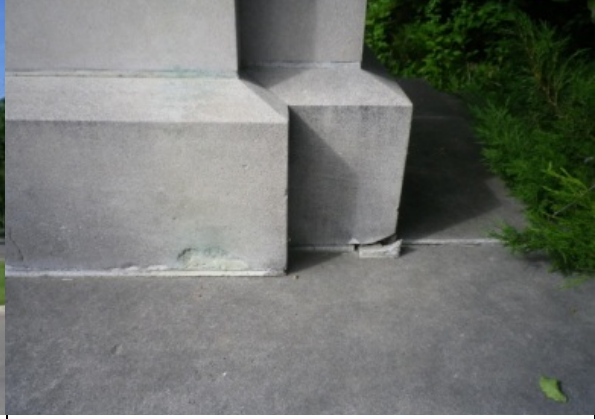
Photo 4: Loose Mortar and weathered Sandstone at base of Monument

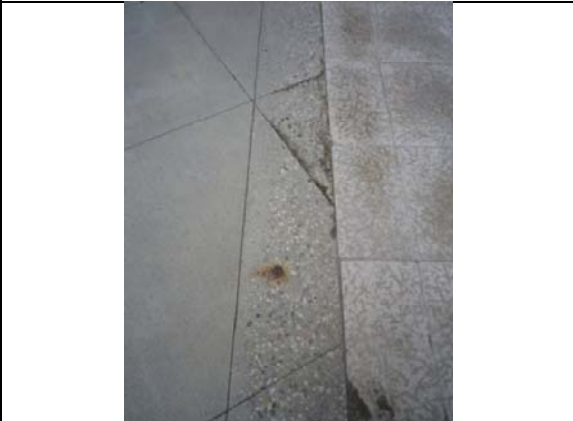
Photo 5: Deteriorated Concrete at North Monuments

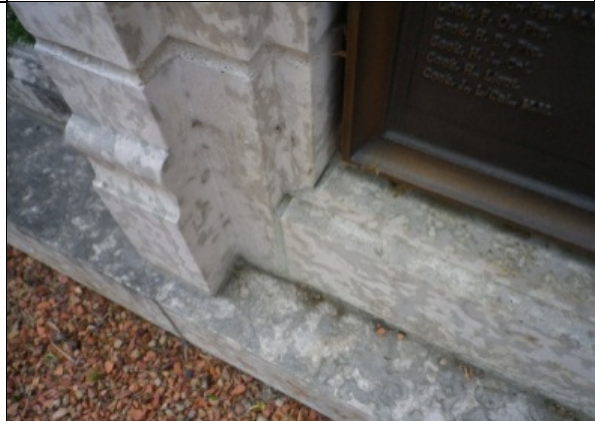
Photo 6: Blackened Surfaces of Tyndall Stone

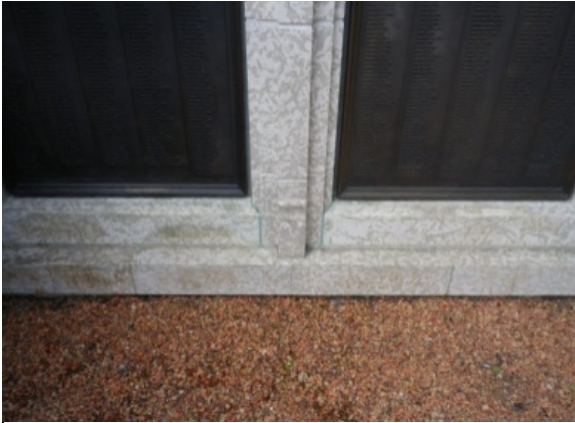
Photo 7: Green Stains in the mortar joints on the South Monument

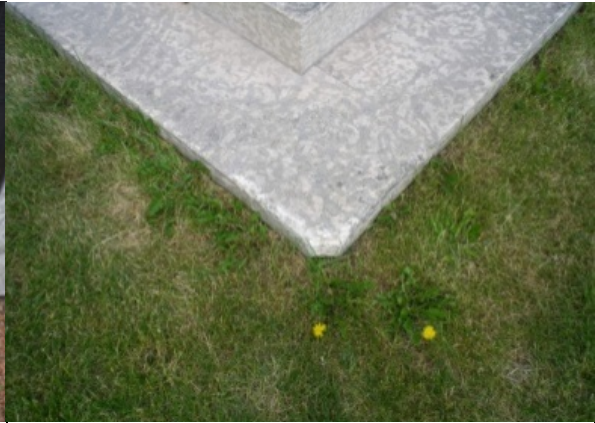
Photo 8: Broken Corner at the base of South Monuments

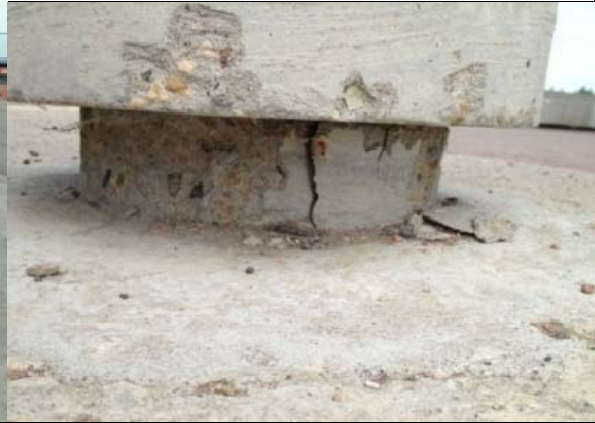
Photo 2: Sprawling concrete on center monument

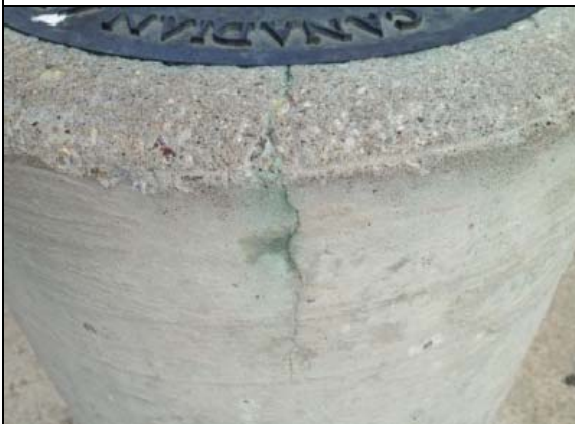
Photo 3: Crack on the top of center monument

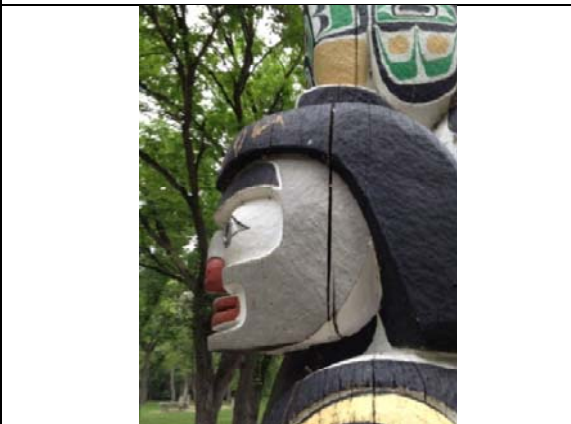
Photo 3: Shrinkage Cracks in the Totem Pole

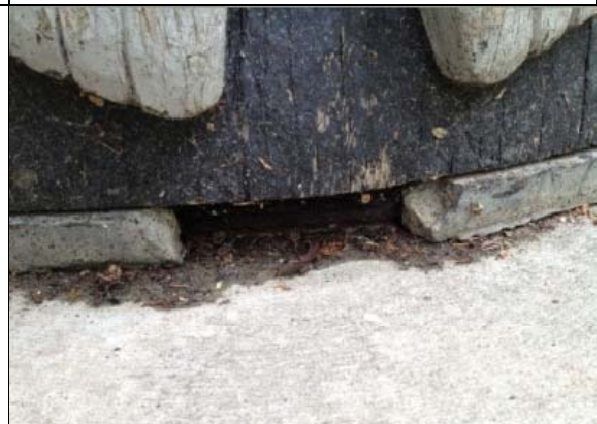
Photo 4: Missing Grout below the Totem Pole

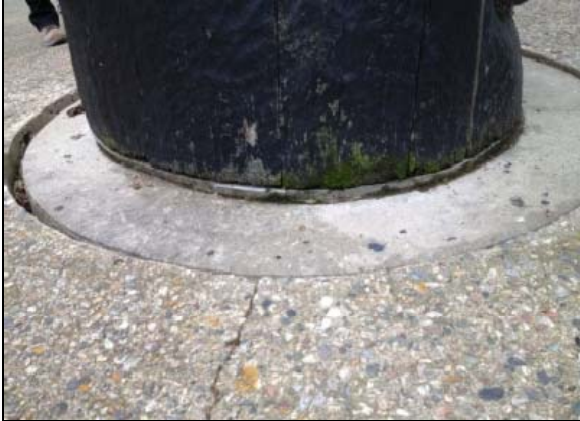
Photo 5: Rotten Wood at the Base of the Totem Pole

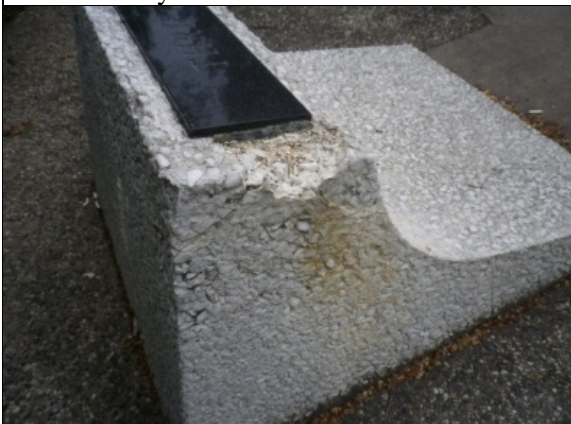
Photo 3: Broken Edges

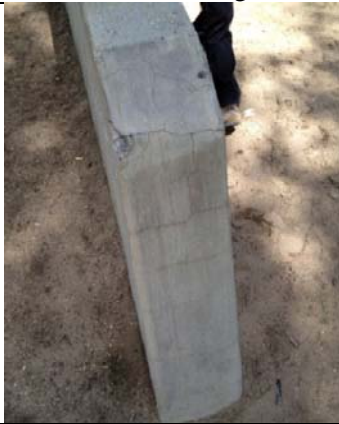
Photo 5: Damaged Concrete on West end of Concrete Retaining Wall

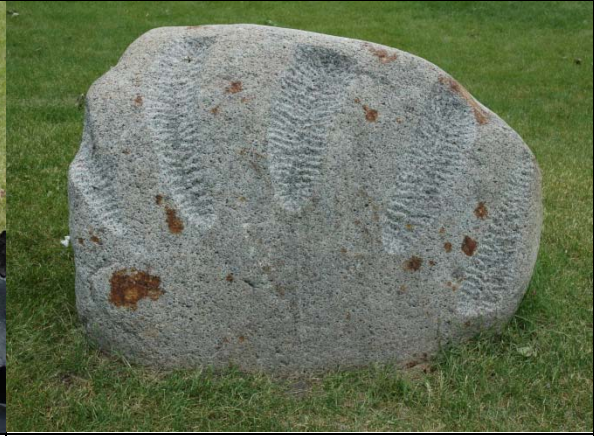
Stone 6 example of red iron rust stains

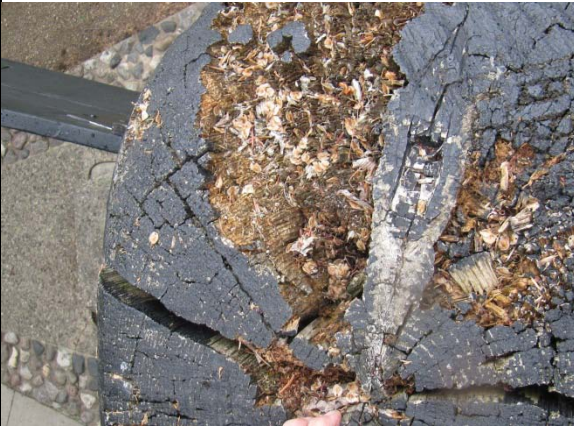
Wood rot on top of the head of the Totem Pole

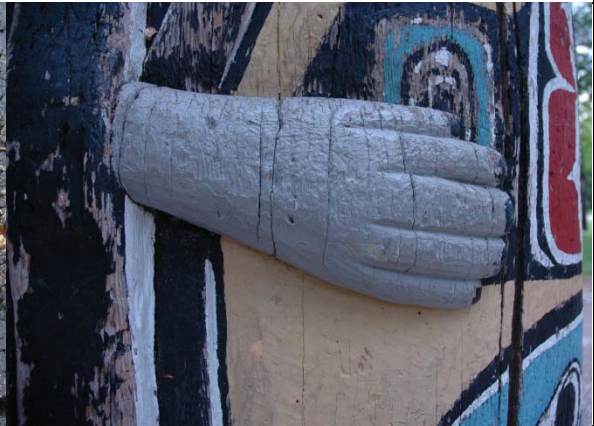
Large cracks running down the Totem Pole

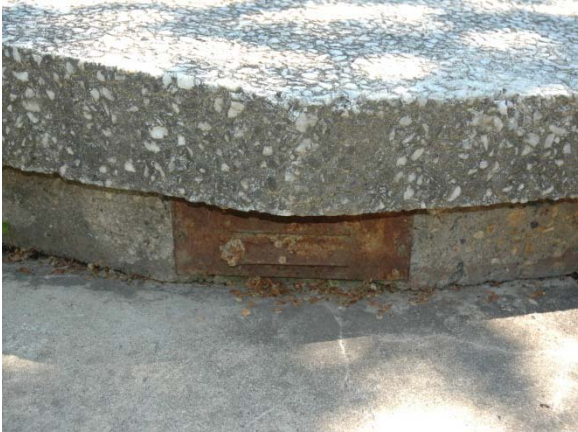
Rusted/corroded metal plates on base of main structure

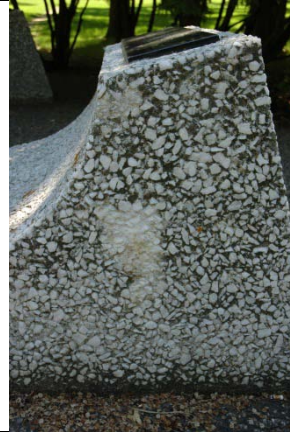
Kind structure example of biological growth

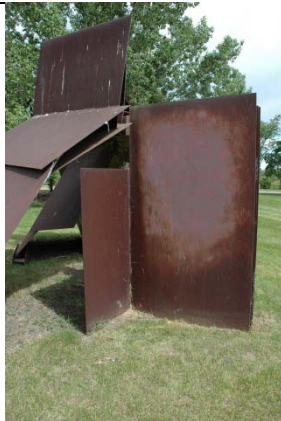
Damage to material from graffiti removal.

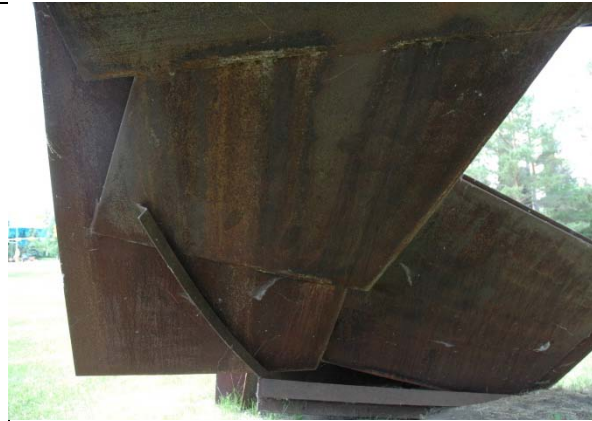
Uneven weathering on underside of sculpture.

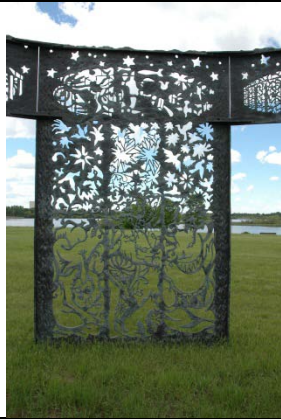
Example of copper malachite corrosion (green colouration) on the surrounding panels.

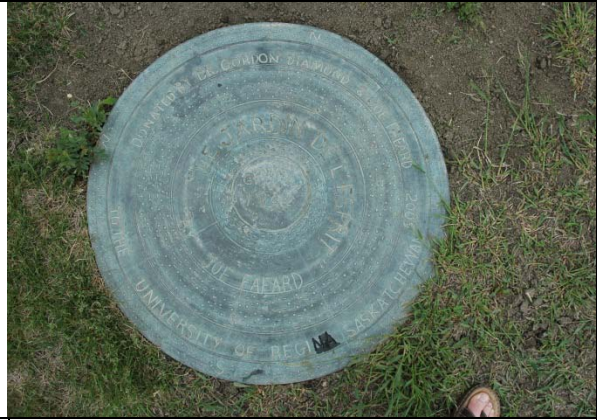
Corrosion and discolouration of central plaque.

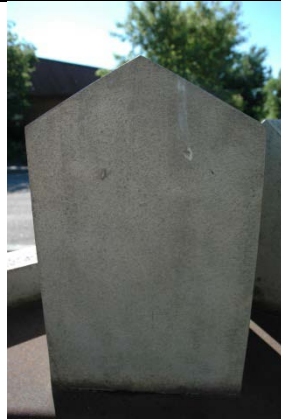
Dented center structure
